Microphone RFI in *microKEYER II*

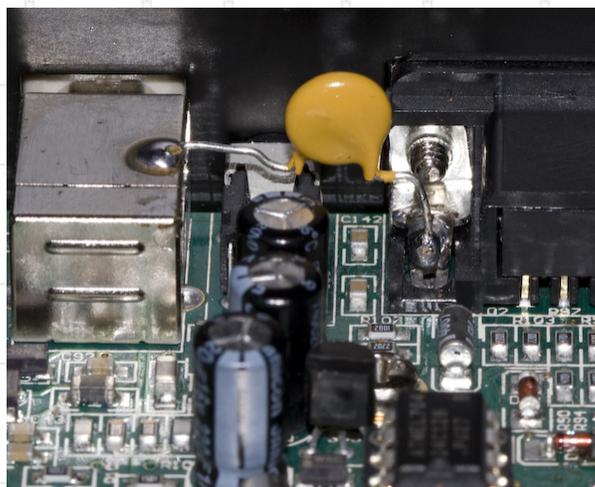
The problem: *microHAM* have been receiving reports of distorted microphone audio in otherwise normally functioning *microKEYER II*. Although *microKEYER II* has been tested for operation in high RF fields, we have found that when the antenna is very close to the ham shack, the antenna is not well balanced (lack of effective balun), or open wire feedlines are used, radiated RF can couple to the shield of the USB cable and from the shield of the USB cable and from the USB cable into the microphone preamplifier resulting in distortion.

In *microHAM* interfaces the shield of the USB cable is not connected to the radio ground. All *microHAM* interfaces are designed to provide complete DC and low frequency isolation between the computer and radio in order to eliminate "ground loops" and the hum/distortion they cause. Unfortunately, many modern computers fail to provide suitable RF grounds and bypassing and the ferrite chokes commonly used for noise reduction reduce the effectiveness of the bypassing that is present. Due to the difficulties *microHAM* have been looking into ways to improve RF bypassing of the USB cable without losing the benefits of galvanic isolation.

The solution: RFI rejection can be improved significantly while maintaining galvanic isolation and without causing ground loop problems by installing a capacitor from the shield to ground. This change has been incorporated in production for *microKEYER II* serial number 765 and higher.

Those who are experiencing RFI in the microphone circuit can add bypassing in the field by installing a 0.001 - 0.01 μ F high voltage capacitor (the value is not critical) from the shield of the USB connector to the metal mounting bracket of the DB37 connector as shown here.
